NATIONAL PROGRAM FOR INSPECTION OF NON-FEDERAL DAMS  
WHEATSTONE BROOK DAM (CT 00167) PHASE I INSPECTION  
REPORT(U) CORPS OF ENGINEERS WALTHAM MA NEW ENGLAND DIV  
F/G 13/13

WHETSTONE BROOK DAM  
CT-00167

### WHETSTONE BROOK DAM - CT 00167

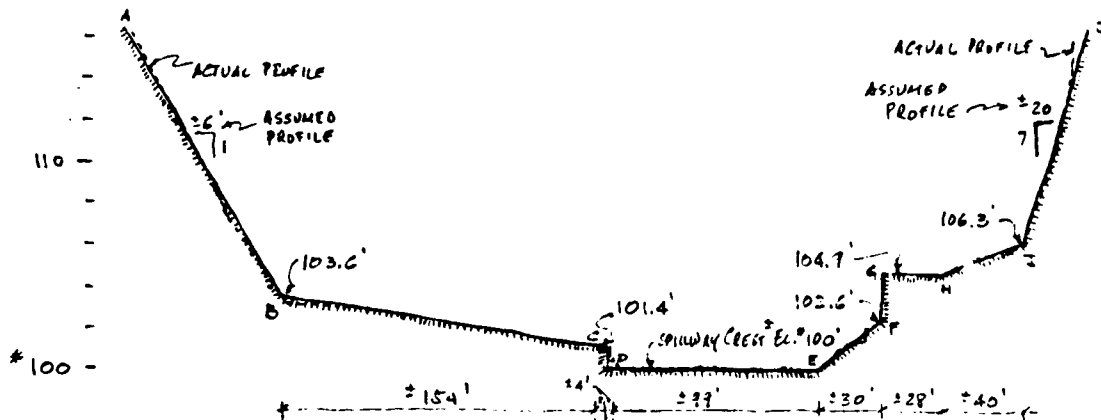
WHETSTONE BROOK DAM  
 APPROXIMATE OVERFLOW PROFILE

SPILLWAY (2) 99' LONG, BROAD-CRESTED (2) 6' B'KATH WITH ROUGH AND UNEVEN CREST FORMED BY A COARSE CONCRETE CAP DUMPED OVER TO REPAIR THE ORIGINAL STONE MASONRY. THIS COARSE CONCRETE ALSO CAPS THE SLOPING SECTION TO THE RIGHT OF THE DAM (SEE PROFILE ECT. CF) WHICH IS ALSO ASSUMED AN EXTENSION OF THE SPILLWAY.

THE OVERFLOW SECTION EXTENDS ON HOSTLY CLEAR TERRAIN INCLUDING ROADS (PAVED (RIGHT); DIRT (LEFT)) AT BOTH SIDES OF THE DAM; ASSUME  $C=2.8$  FOR THE FLOW OVER THE ENTIRE SECTION (SEE PROFILE BELOW).

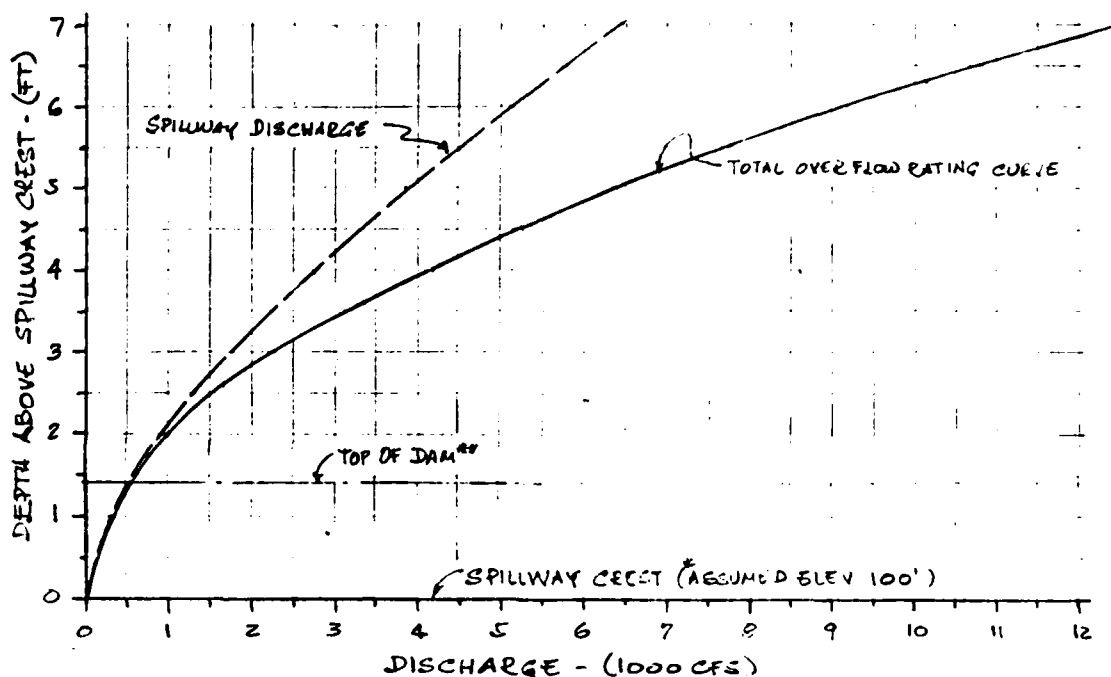
## (ii) WETSTONE BROOK DAM - OUTFLOW RATING CURVE

\*\* ASSUMED TOP OF DAM AT LOW OVERFLOW POINT TO THE LEFT OF THE SPILLWAY.
